# Alternate Nozzle Ablative Materials Program

N. A. Kimmel

September 1, 1984

Prepared for  
**NASA Marshall Space Flight Center**  
through an agreement with  
**National Aeronautics and Space Administration**  
by  
**Jet Propulsion Laboratory**  
California Institute of Technology  
Pasadena, California

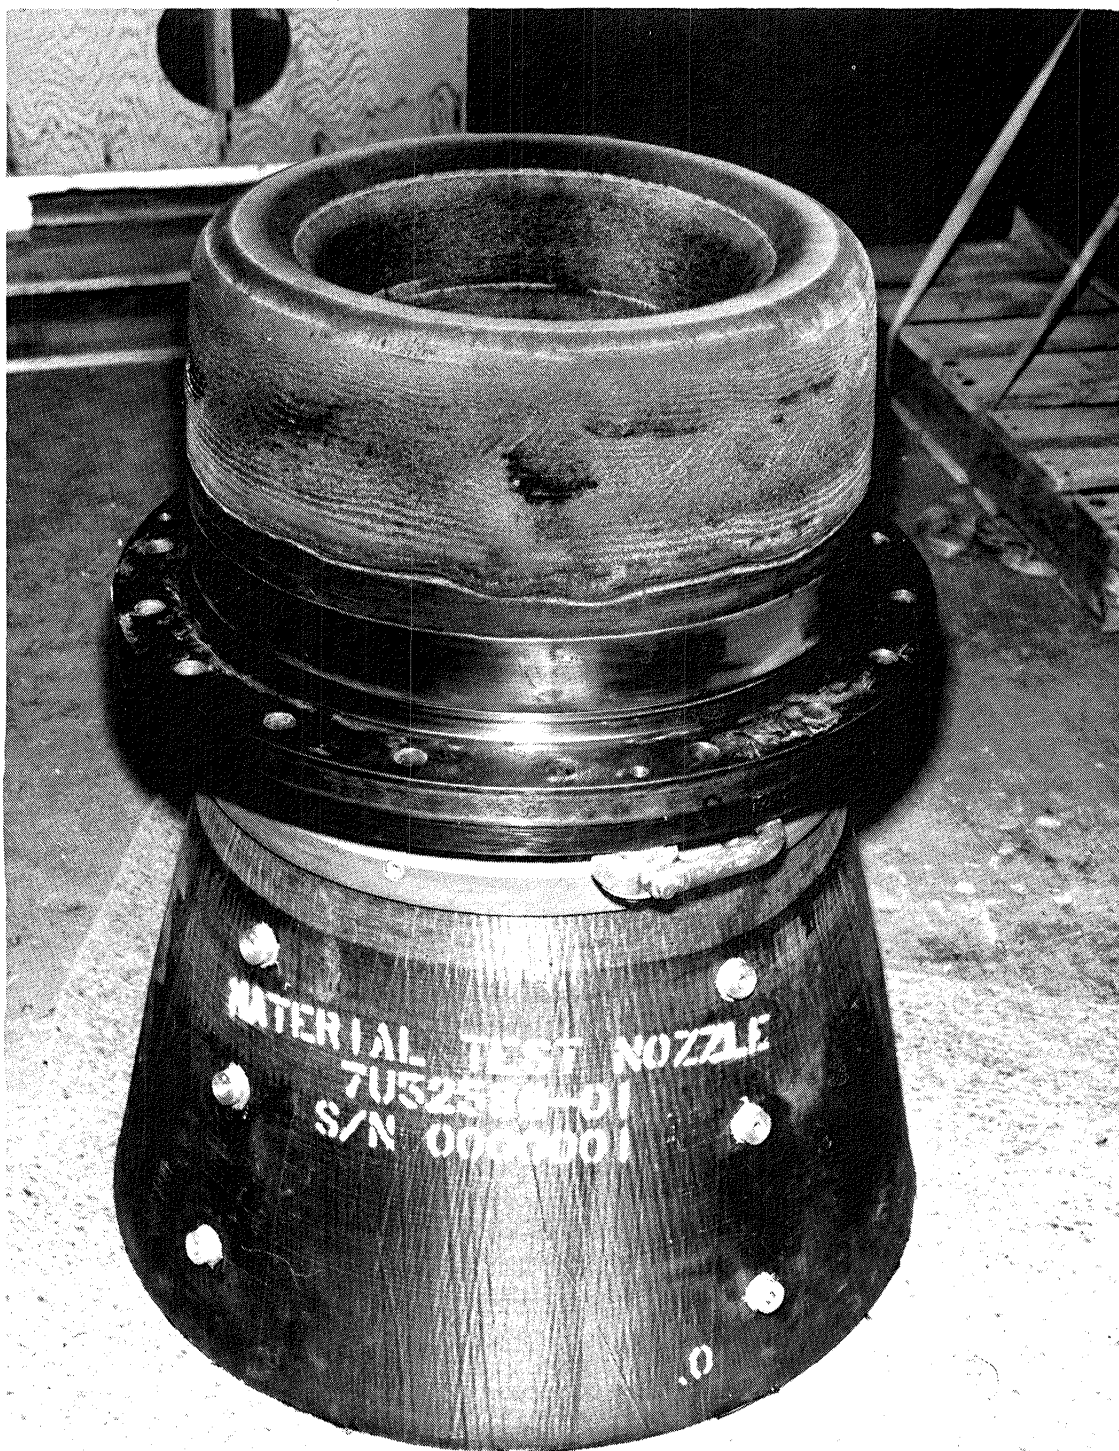
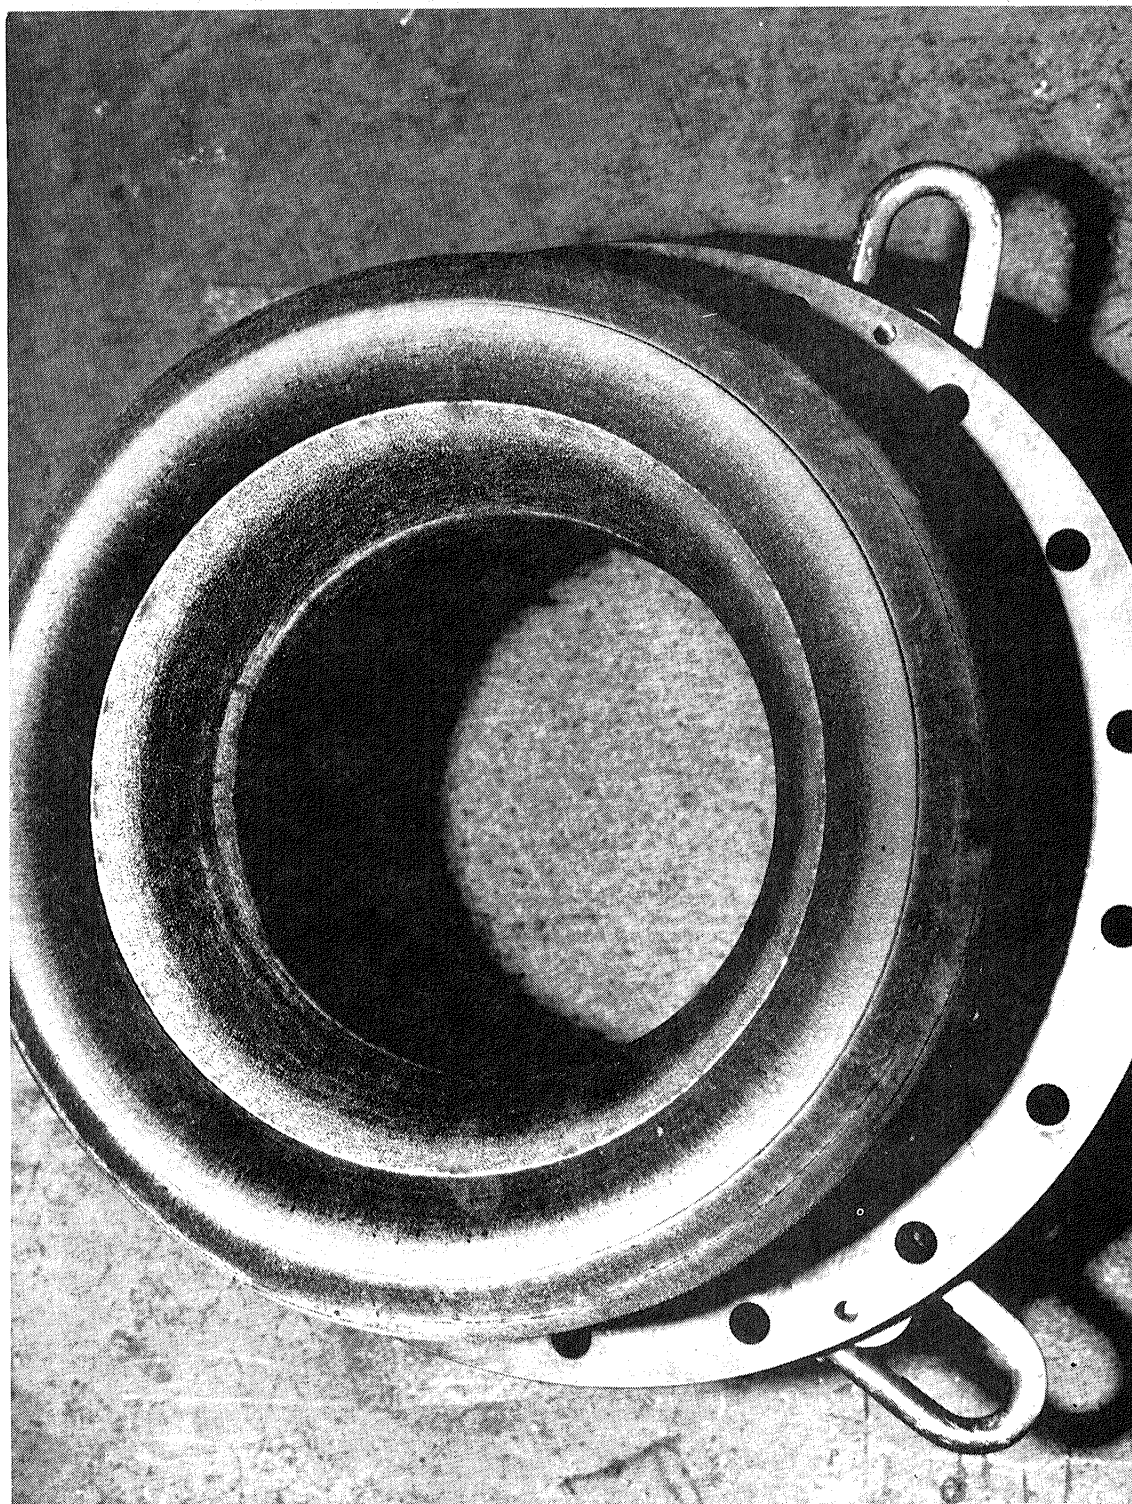
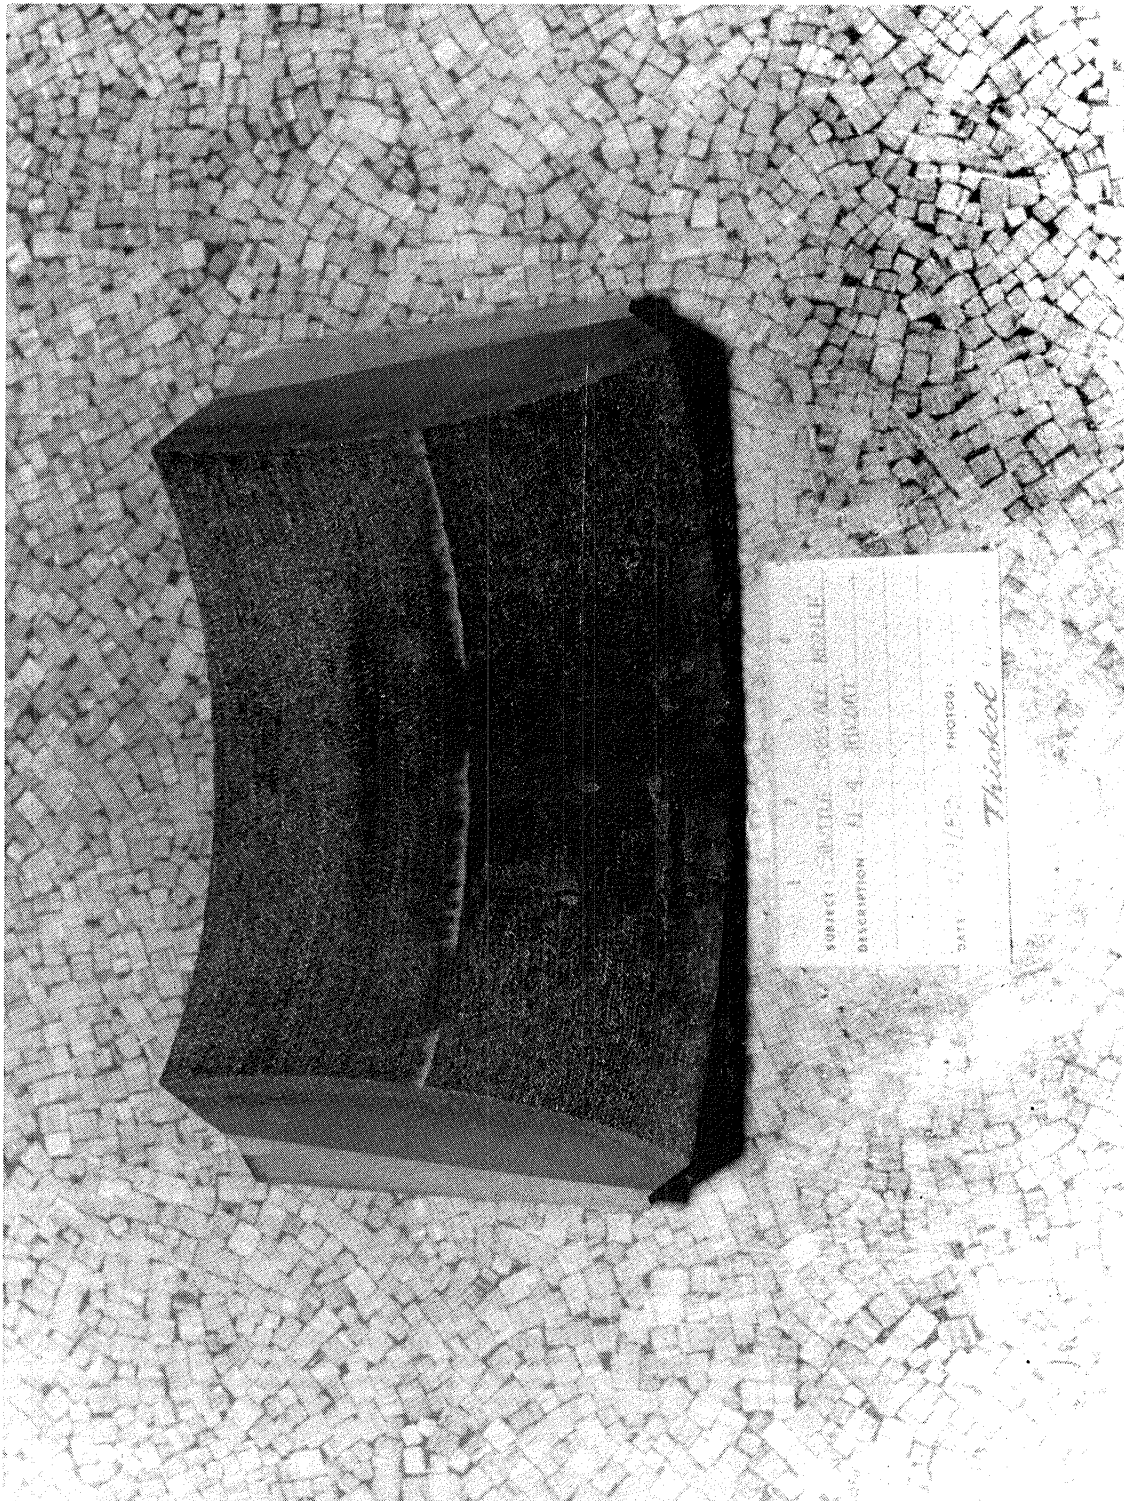
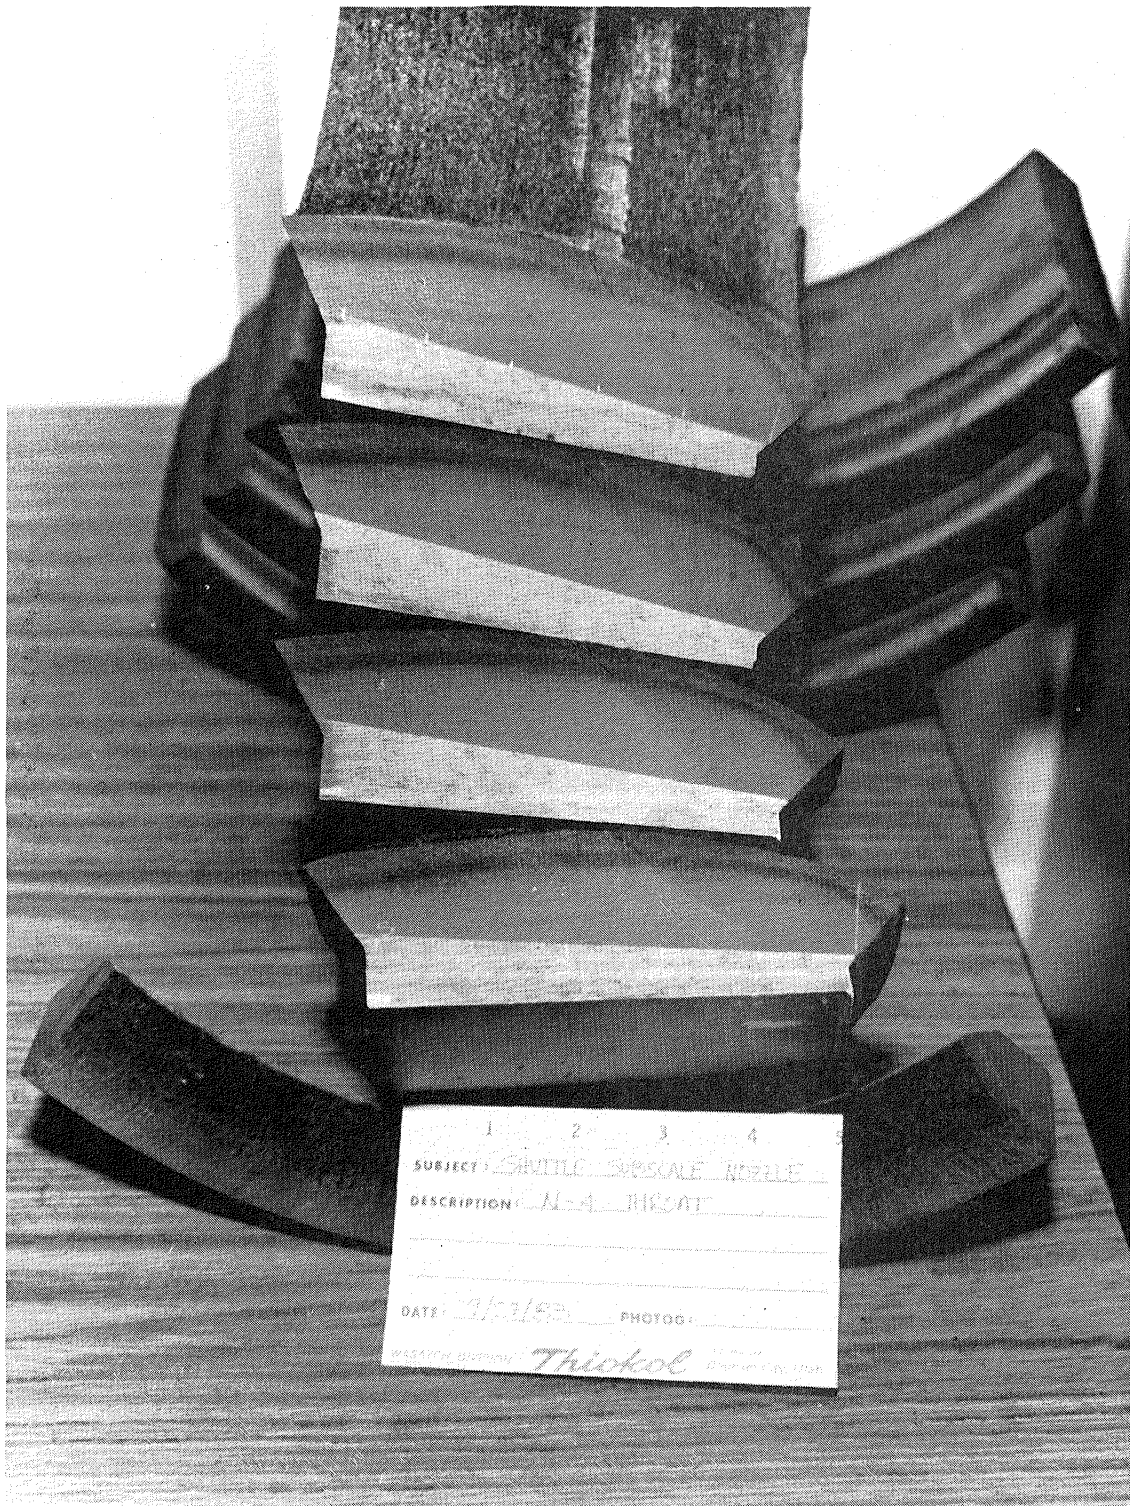
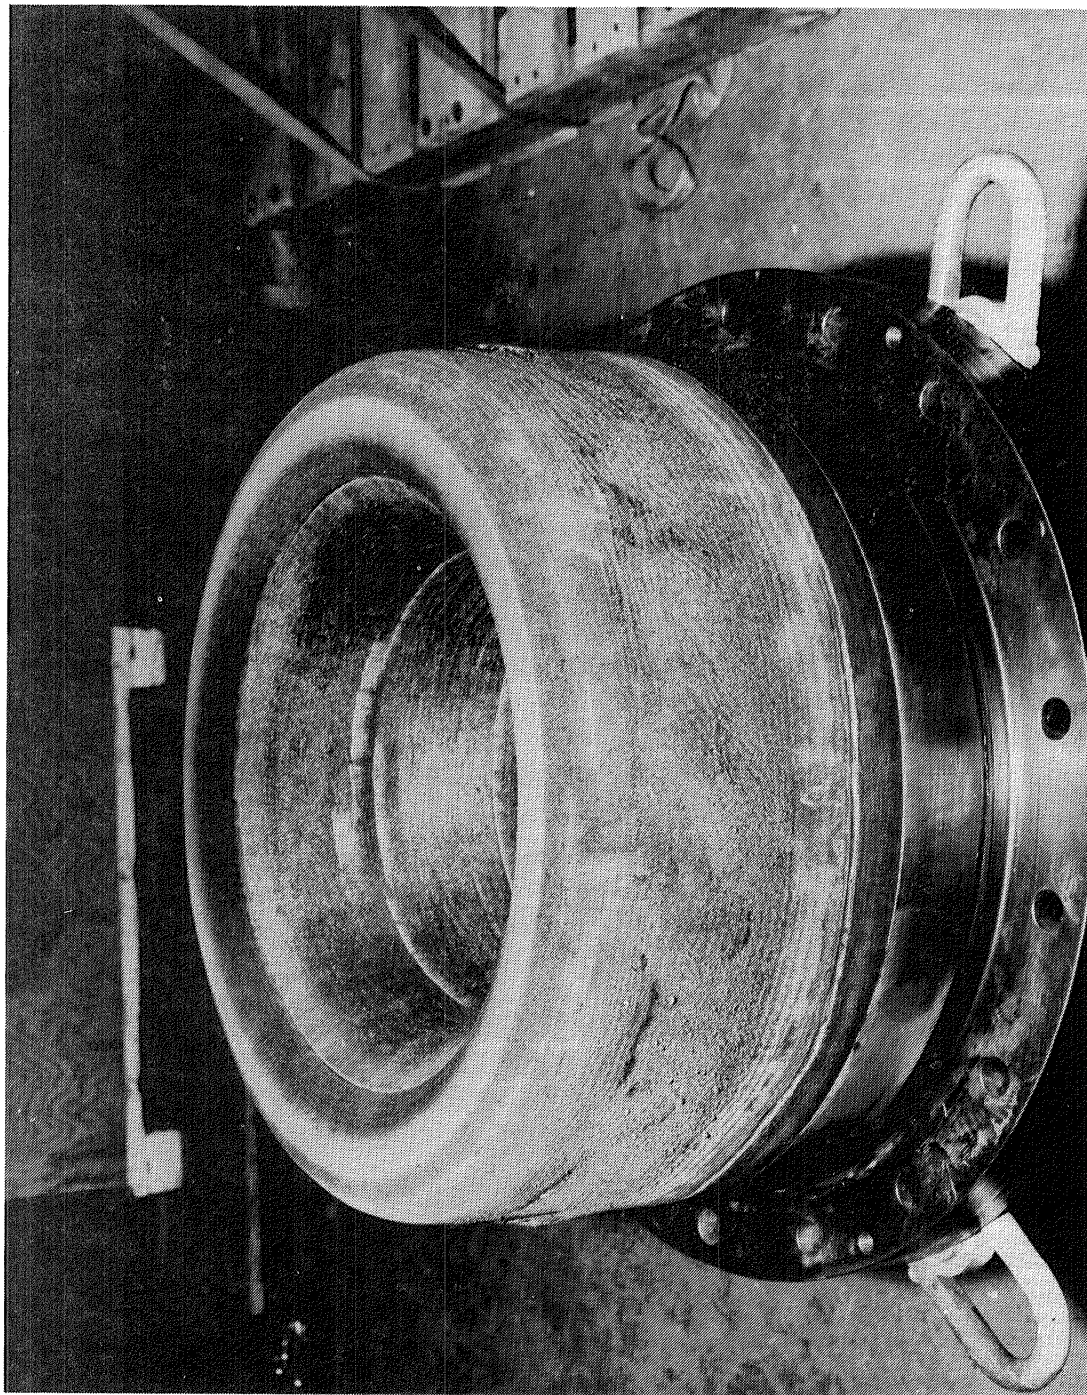
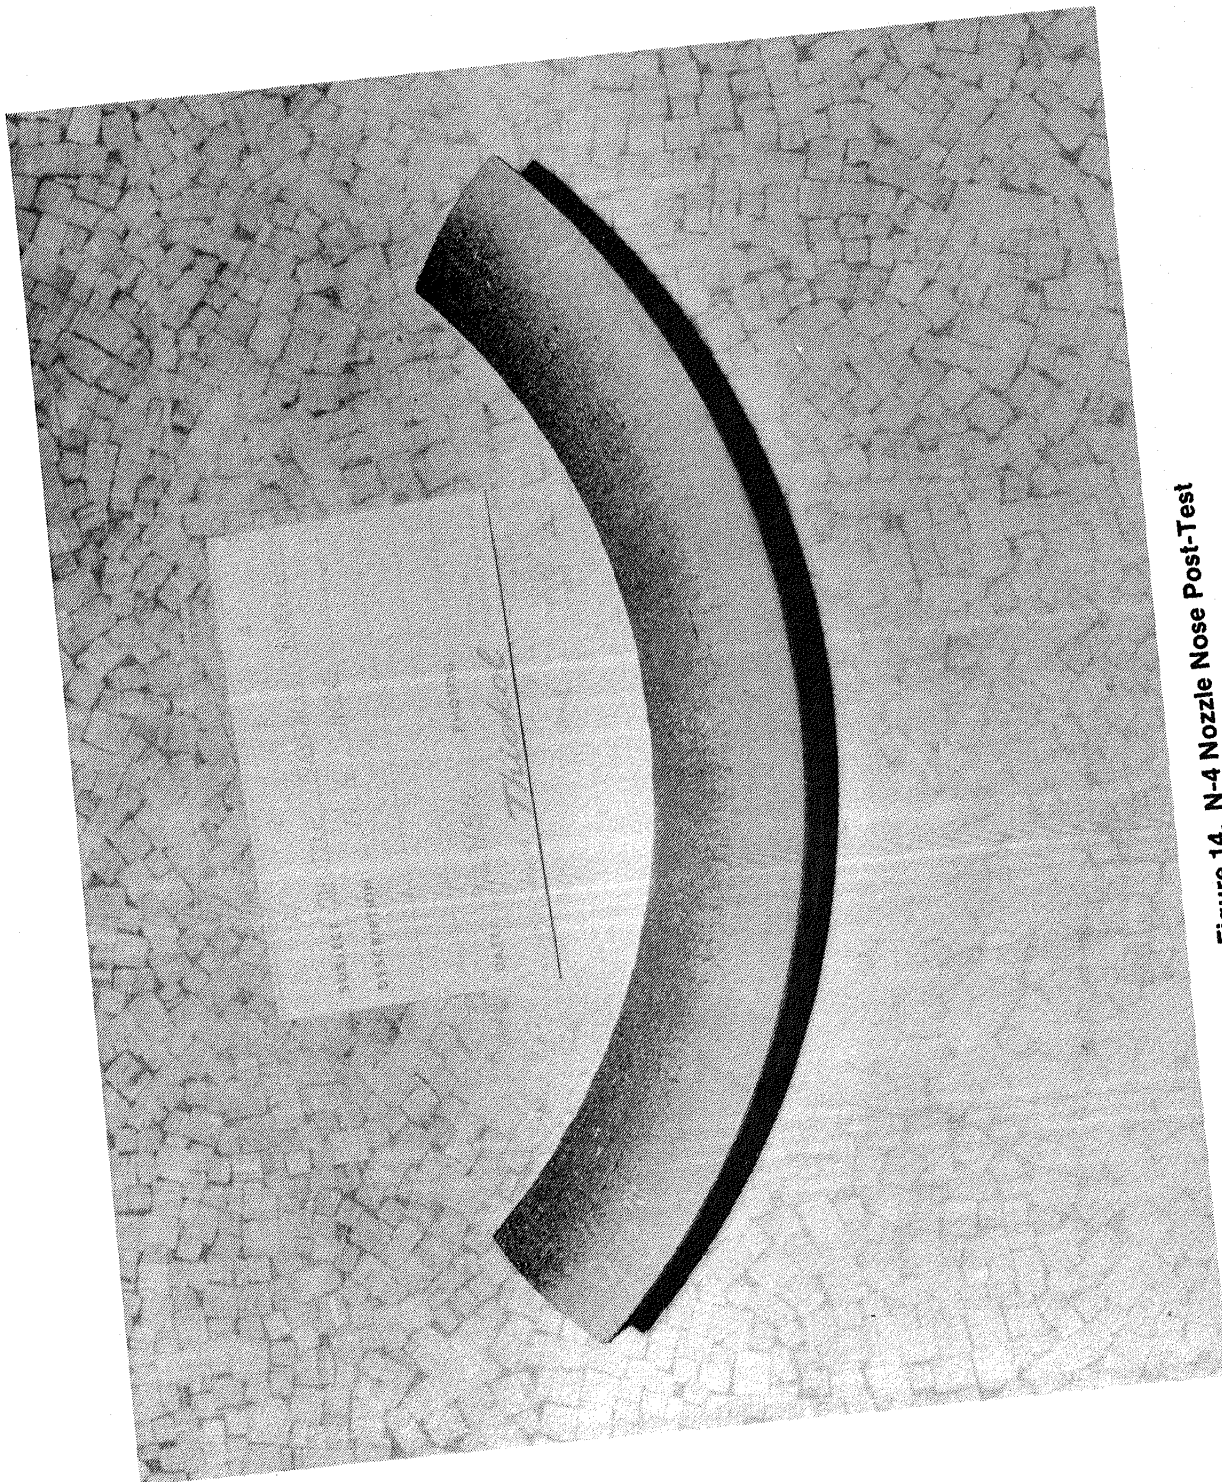
The metal housing showed no indication of damage. The post-test condition of the plastics is shown in Figures 9 through 21.

The overall performance of the N-4 nozzle was good. Erosion was smooth and uniform. No major anomalies were observed. The nose, throat, and forward exit cone showed excellent integrity with very even erosion and char profiles.
